## **PUBLISHED PROJECT REPORT PPR636**

### **A83 Rest and be Thankful: Ecological and Related Landslide Mitigation Options**

**M G Winter (TRL) and A Corby (Transport Scotland)**

**Project Ref:** TRTC 2000-097

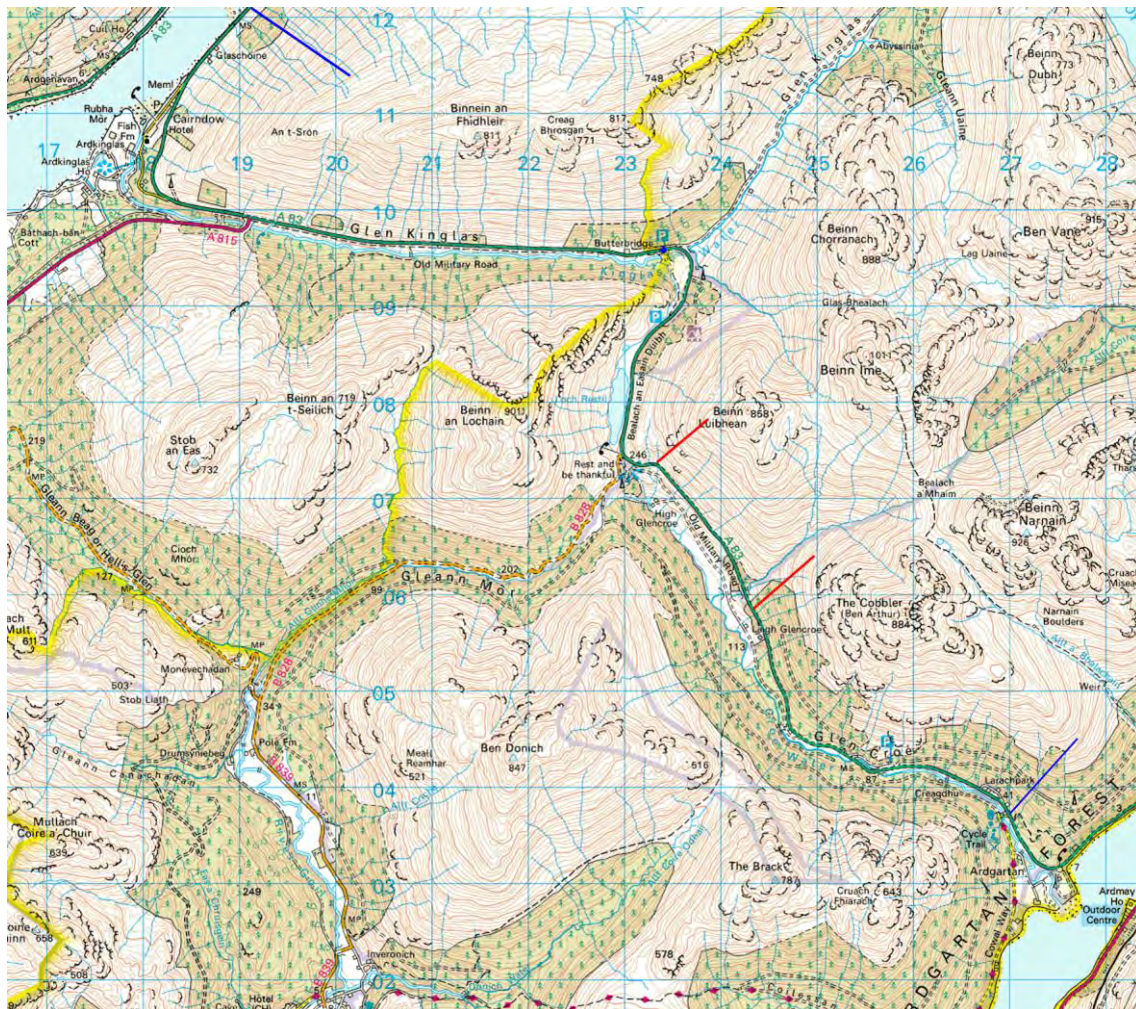
**Figure 1. Map showing the notional geographical limits of debris flow occurrence affecting the A83 trunk road in the general area (blue lines) of the Rest and be Thankful and the approximate limit for events since 2007 (red lines). Reproduced by permission of Ordnance Survey, on behalf of HMSO, © Crown copyright and database rights, 2012. All rights reserved. Ordnance Survey Licence number 100046668.**

Debris flows are a regular occurrence in the general area of the A83 at the Rest and be Thankful. For over 20 years the first Author has observed such events on a regular, approximately annual, basis as they affect the area between Ardgarten and west of Cairndow. In recent years, broadly since 2007, these events have occurred in a somewhat more concentrated area, affecting the westbound approach to the Rest and be Thankful (Figure 1). These events are sourced on the south-westerly facing slopes of Beinn Luibhean (Figure 2).

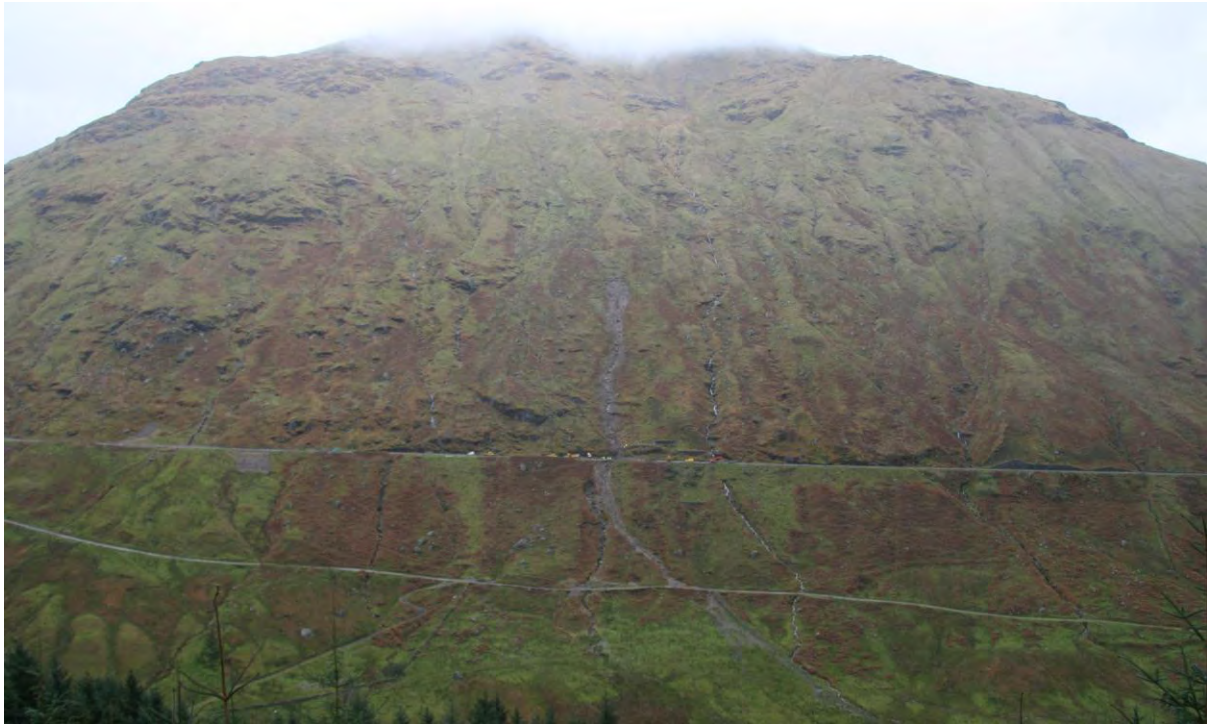
**Figure 2. The A83 on the approach to the Rest and be Thankful showing the south-west facing slopes of Beinn Lubhean (image dated October 2007).**

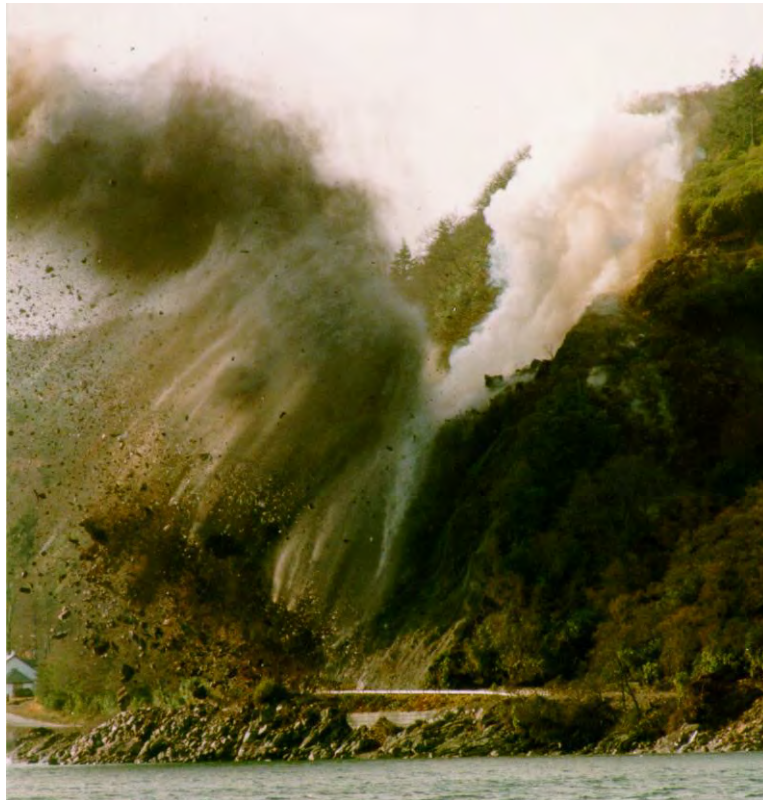
**Figure 3. Rock blasting adjacent at the A83 Artilligan (image dated May 1997).**

It is not entirely clear what inspired the correspondent to suggest this approach but a degree of observational experience of rock blasting in either a quarry or infrastructure context seems most likely. Certainly there is a variety of forms of blasting that is used for varying purposes in the context of rock bodies and slopes. These include, in the quarrying context, blasting to break apart large bodies of rock to allow further processing to produce aggregate, for example. The detailed explosive charges can be configured to better approximate the target aggregate size range required. In an infrastructure construction context blasting is used to form cuttings (Figure 3) either using bulk blasting techniques or pre-split techniques, the latter producing a smoother and lower maintenance final face, although one that is not necessarily in keeping with adjacent naturally weathered rock slopes and outcrops (Figure 4). Blasting is also sometimes used to scale loose material from existing rock slopes.

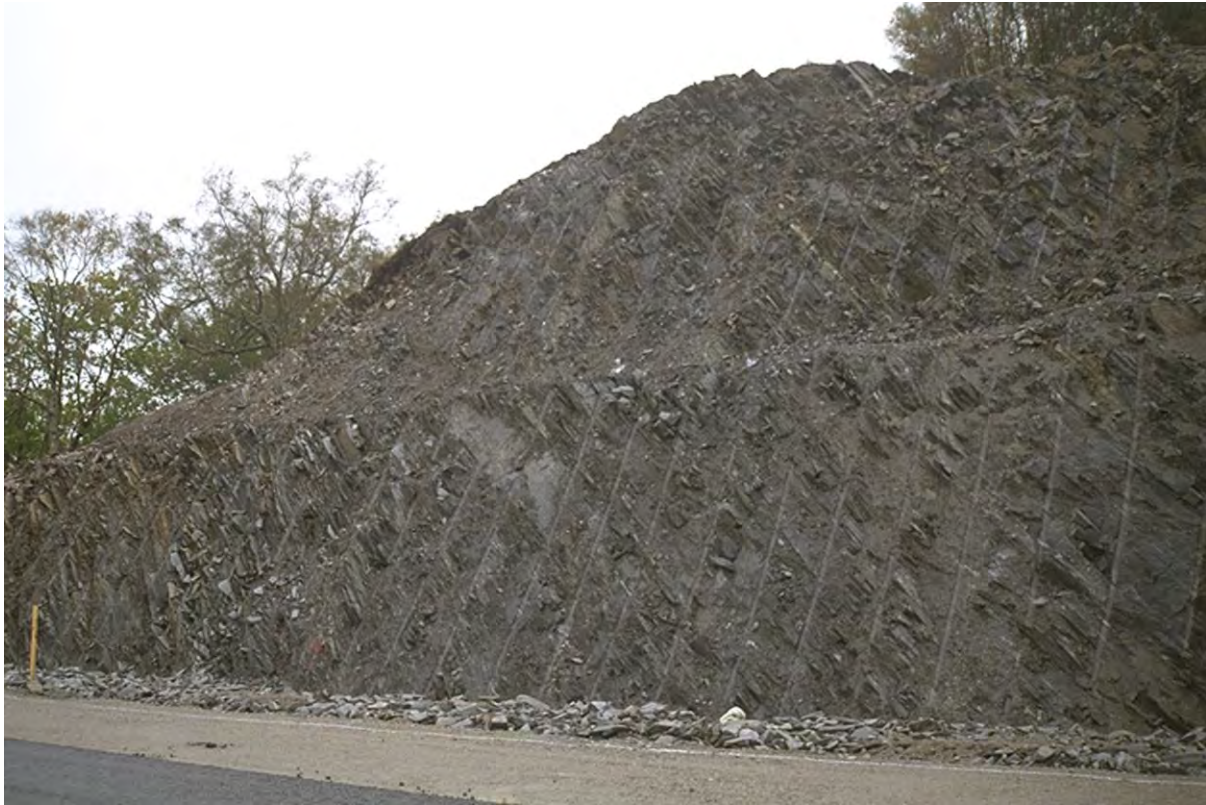
**Figure 4. Pre-split rock cut slope on the A830 near Arisaig.**

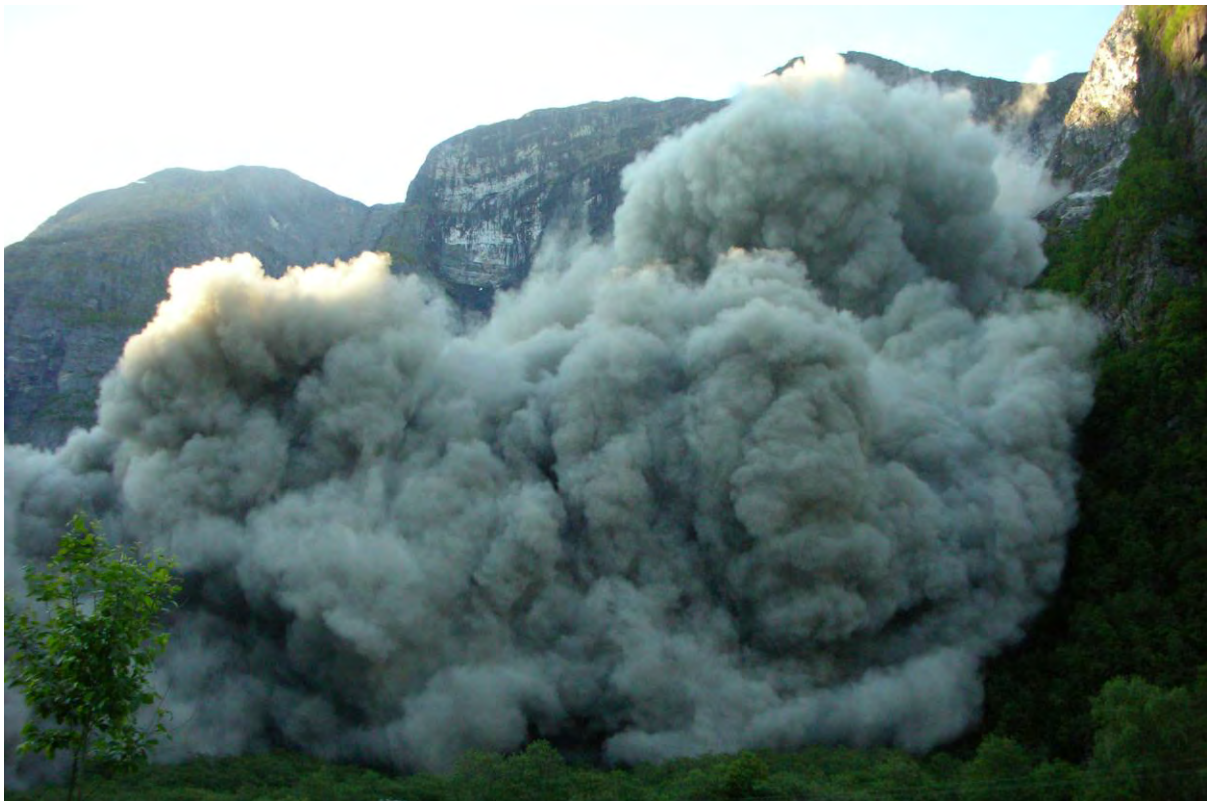
**Figure 5. Dust cloud caused by blasting at Skjerpung, Norway in 2010. The cloud travelled around 7km down the valley and fjord of Nærøydalen. (Photograph by Paulsen, courtesy of Ulrik Domaas, Norwegian Geotechnical Institute.)**

Other issues that must be considered include the removal of the material resulting from the blast and the safety of workers involved in the operations. Perhaps the greatest concerns with this type of operation, apart from the relative unlikelihood of success, are the unpredictability of the movements of the materials during the process, particularly with respect to size of any landslide event triggered and its likely runout distance, and the means by which the very large amounts of blasted material may be removed from site and disposed. In addition, blasting on such a scale is likely to cause a significant dust cloud. Figure 5 shows the dust cloud from the Skjerpings blasting operation in Norway in 2010 – in this case the dust cloud travelled approximately 7km down the valley and fjord of Nærøydalen. This raises the prospect of a dust cloud that could travel from the Rest and be Thankful as far as Lochgoilhead, Arrochar, the far shores of Loch Fynne or Loch Long, or even Loch Lomond depending on the prevailing wind direction at the time of blasting.

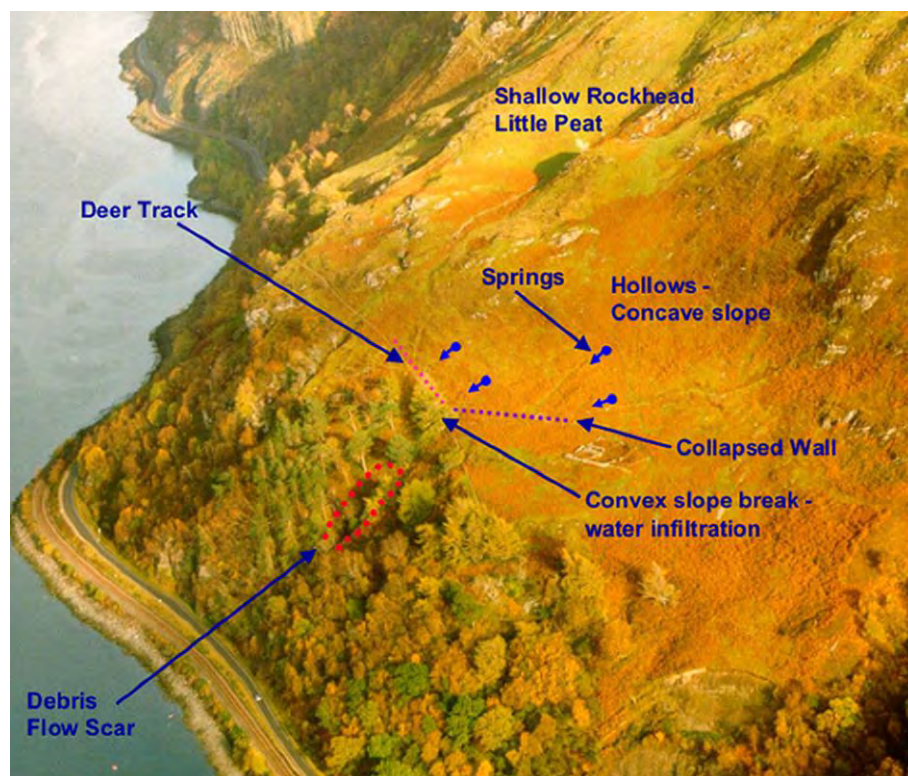
**Figure 6. Aerial oblique photograph of the location of the October 2001 debris flow on the slopes above the Strome ferry Bypass. Contributory factors are highlighted including the effect of deer tracks in concentrating water flow. (From Nettleton et al., 2005a.)**

deleterious effects of deer tracks on slopes above the A890 at Strome ferry (Figure 6) which do, indeed, create preferential drainage paths on the slope. These tend to be linear, flatter benches on the hillside, often broadly parallel with the contours and are often located at breaks of slope. This disrupts the flow of water and creates preferential drainage routes and increases infiltration with an overall negative effect upon stability. This can cause water to flow along the path spilling over onto the slope, concentrating the flow at a low point potentially causing erosion. This phenomenon has been directly observed on forest roads on the slopes above the A887 at Invermoriston by the first Author. In addition, Winter et al. (2006; 2009) reported just such an effect as the old A9 concentrated flow in the manner described causing erosional failures that affected the A9 trunk road in August 2004 (Figure 7). Observations in the Rest and be Thankful locality and elsewhere confirm that sheep similarly follow contour-parallel paths with similar disadvantageous effects.

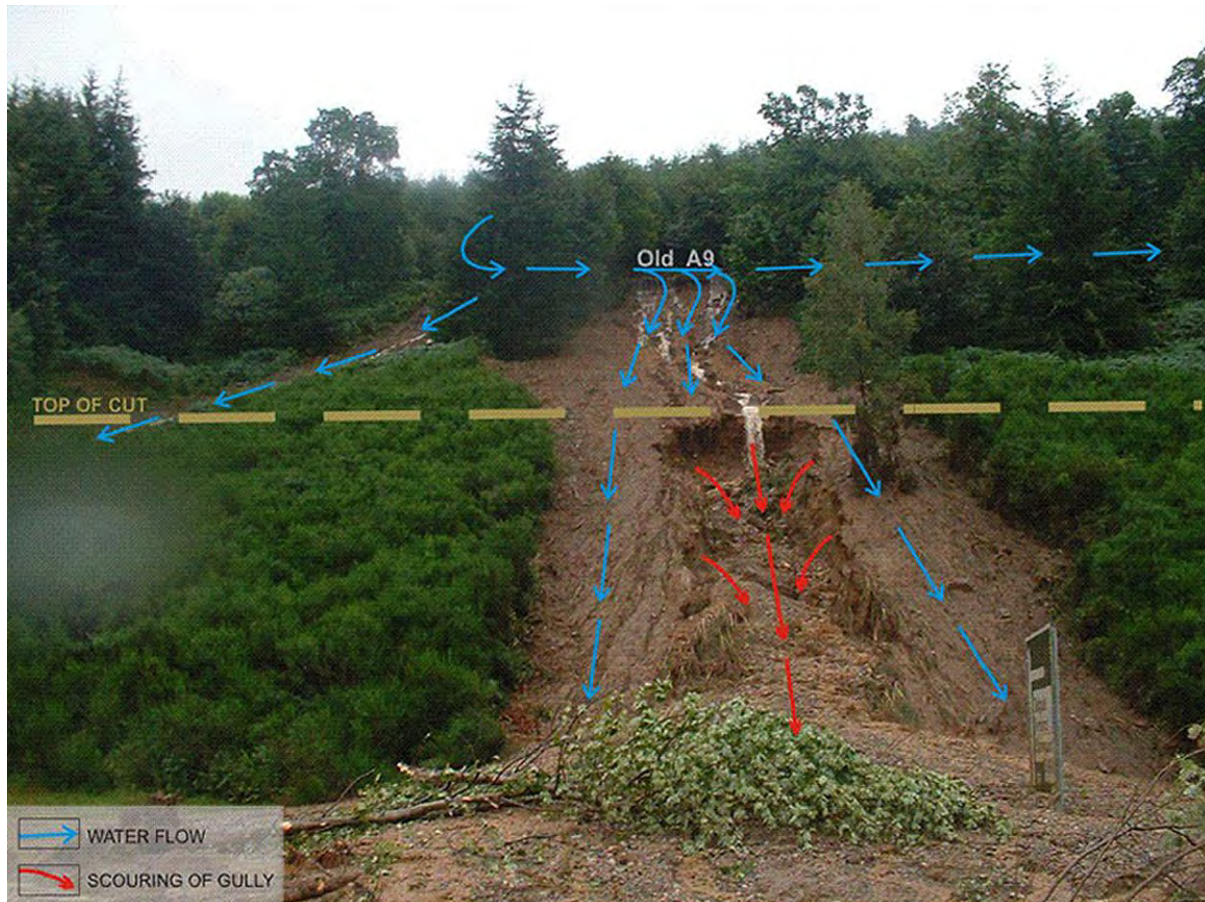
**Figure 7. Influence of old A9 on debris flow at A9 Dunkeld. The central flow is shown and the northern flow can also be seen on the left of the picture. In each case water has flowed along the old road and spilled over the edge at a low point causing erosional debris flows. Photograph dated 11 August 2004. (Courtesy of Alan MacKenzie, BEAR.).**

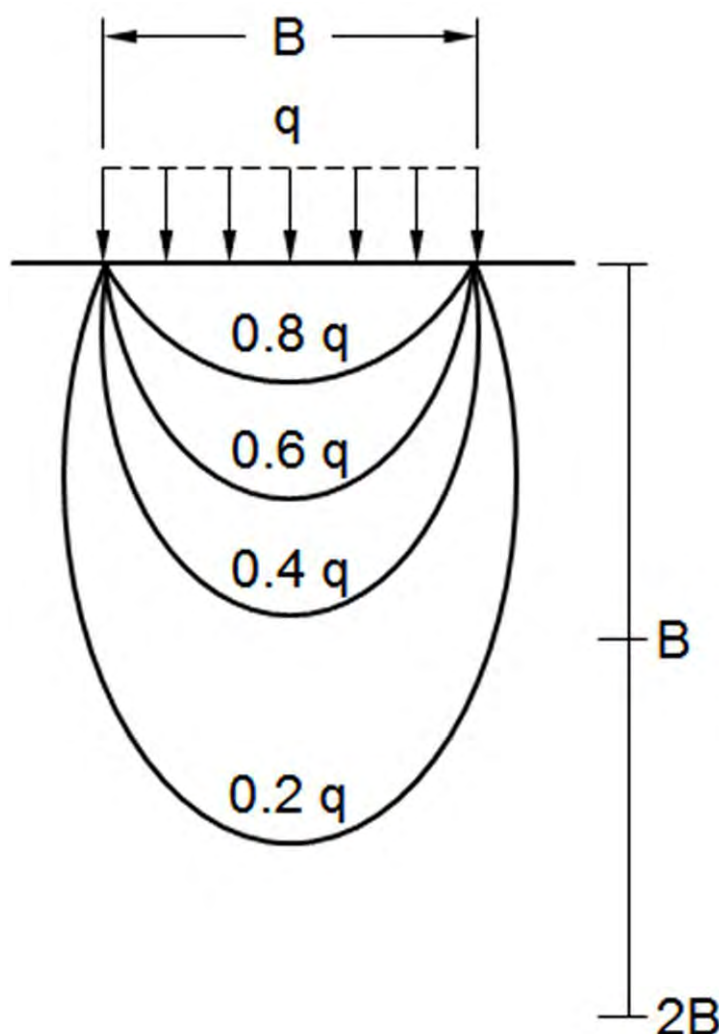
**Figure 8. Sketch of Boussinesq contours of equal vertical stress under a square plate or footing (after Craig, 1983): not to scale.**

When pressure is applied to the ground by a plate, or a hoof, vertical stresses are generated in the ground. The stress contours are illustrated in Figure 8 for a square area in terms of the pressure ( $q$ ) applied by the plate, or by the hoof (the contours for a circular plate are similar but stretch horizontally a little further, that is they appear to be a little more bulbous). If the value of the pressure ( $q$ ) is increased, for a given size of plate, then so does the vertical stress in the ground at a given depth. At a depth of around 1.5 times the width ( $B$ ) of the plate the stress in the ground is around one-fifth that applied to the plate. Thus for a constant pressure a larger plate (which would require an increase in the load) will create greater stresses at a constant depth and stresses in deeper parts of the soil.

4. Assuming that the vertical stress,  $\sigma = 0.4q$  at a depth of  $B$  (which is a reasonable approximation from Figure 8), then at this depth the stress developed by red deer hooves will be around four times that developed by cattle hooves and for sheep hooves it will be around 2.7 times the same figure.

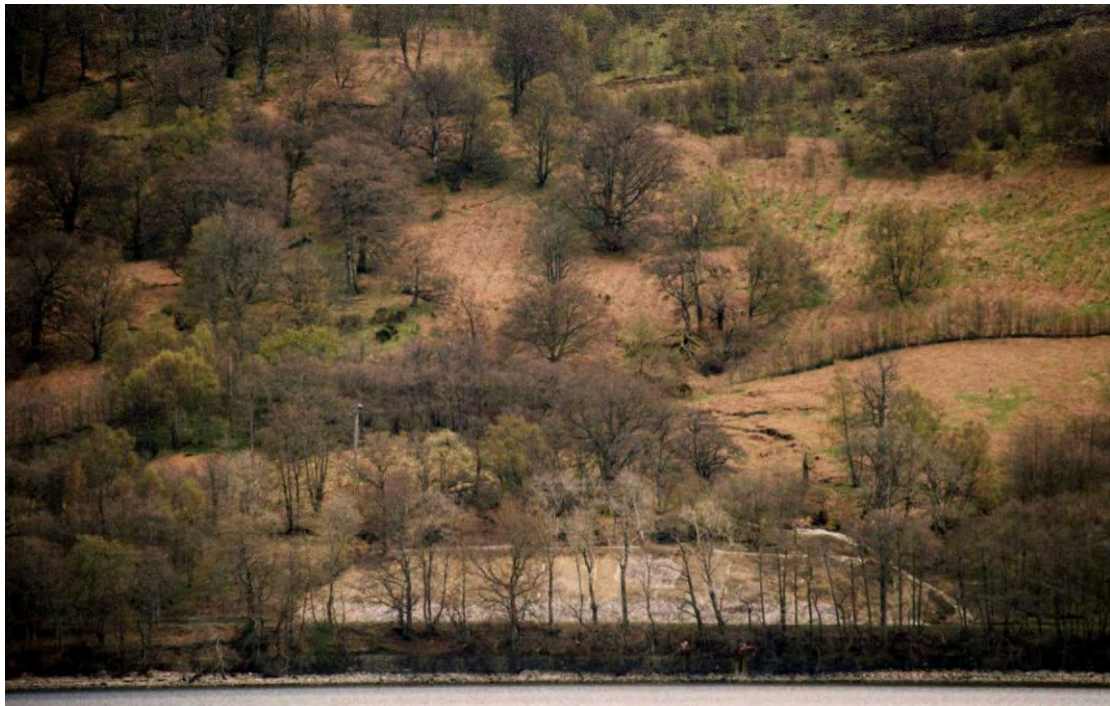
**Figure 9. Translational landslide at A83 Loch Shira. The head of the landslide is located just below the middle of the image and above that point former plough lines left over after forest harvesting may be seen. (Image dated 1995).**

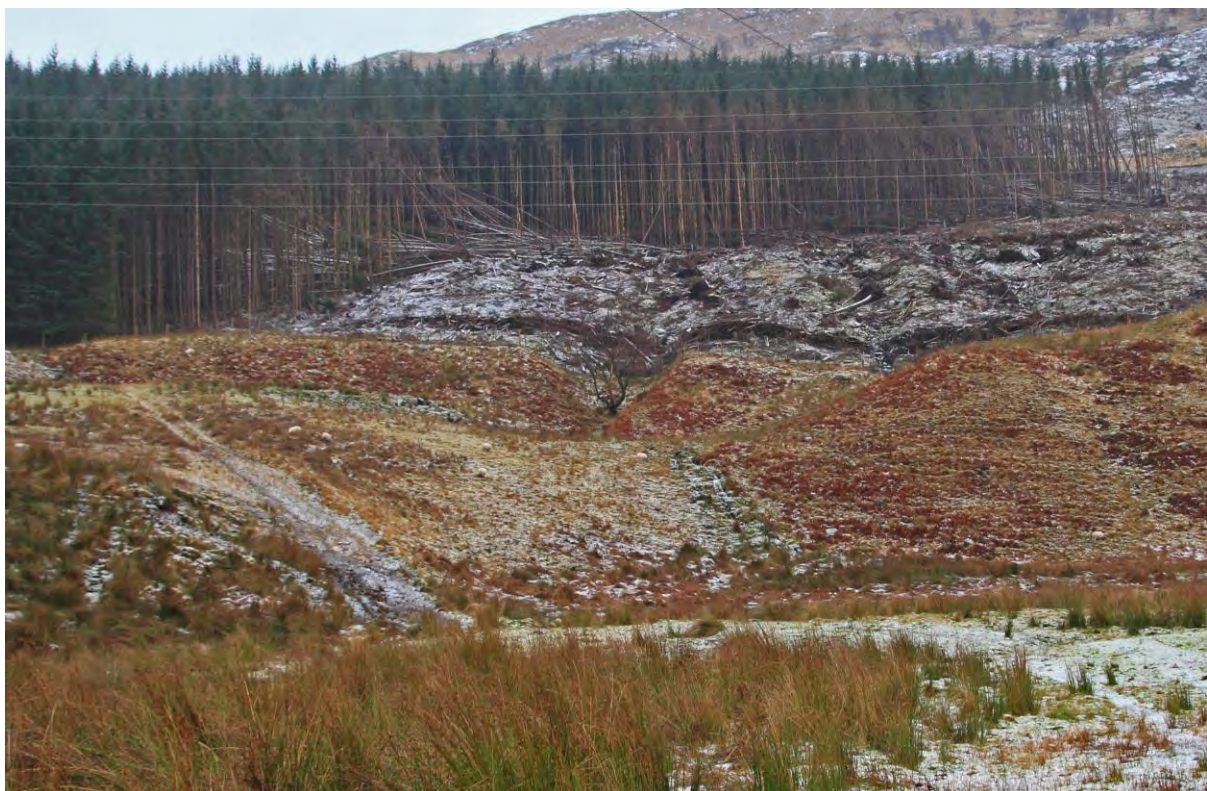
**Figure 10. Windthrow can be clearly seen at the edge of the forested area. The harvesting in the foreground of the photograph has removed the wind-firmed edge of the plantation leaving newly exposed trees vulnerable to the effects of the high winds. (South of A85 Crianlarich to A828, image dated December 2012.)**

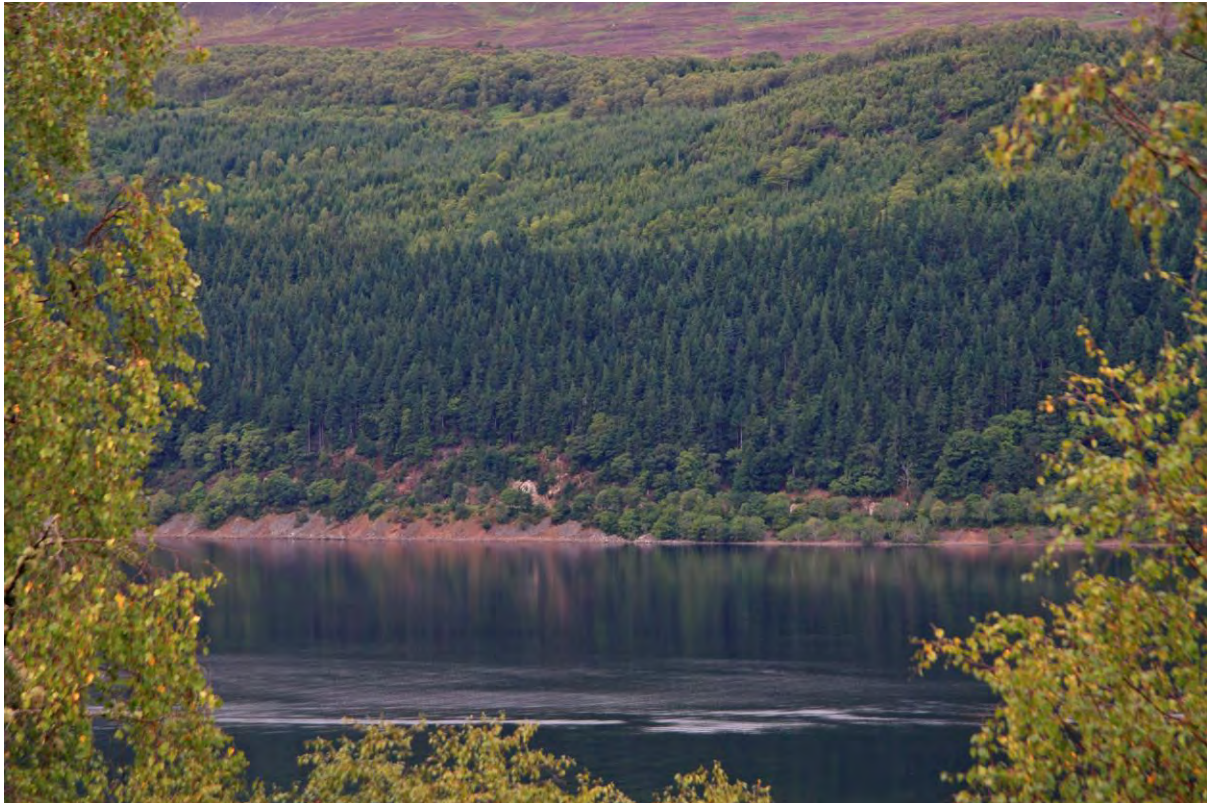
**Figure 11. In this image the A82 runs just above the loch side and larger specimens of tree can be seen on the cut slope to the centre-left of the image and on the steep slope above the cut slope. In places such trees are potentially unstable.**

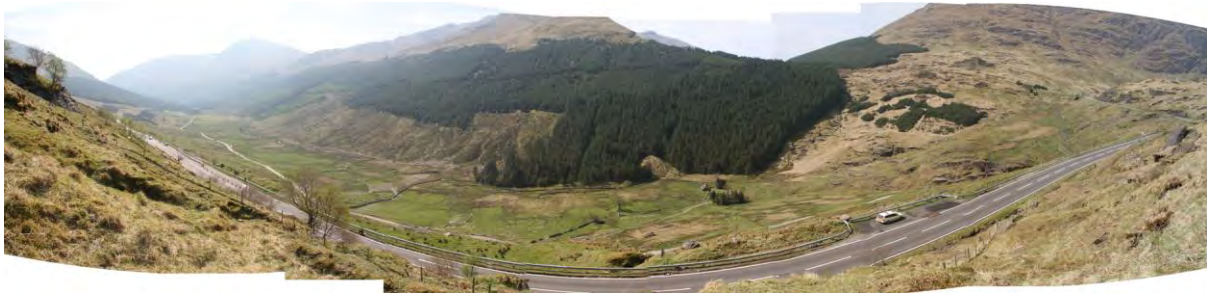
**Figure 12. Photomontage of the A83 and the west side of Glen Croe viewed from the south-west facing slopes of Beinn Lubhean showing single-species, managed, commercial forestry including areas of clear-felling.**

Perhaps the most obvious form of planting for the Rest and be Thankful site would be commercial, managed, single-species plantation (e.g. Figure 12). There are, however, a number of obstacles to this approach. The average slope at the Rest and be Thankful, at around  $36^\circ$ , is at the margins of what would be viable for such managed, commercial activities. In addition, this form of planting would produce relatively uniform trees that would grow to a commercially viable size before being harvested, thus eliminating the beneficial effects. If the trees were to be left in-situ then there would be the potential for the trees to become over-mature and potentially present a hazard resulting from windfall. It is also clear that steepness would be an obstacle to both harvesting and management of the trees on the slope.
